# Vibration characteristics of vaulted masonry monuments undergoing differential support settlement

This paper assesses the feasibility of vibration testing to detect structural damage caused by the settlement of buttresses in the Beverley Minster, a Gothic church located in the UK. Over the past eight centuries, the accumulated support settlements of the buttresses of Beverley Minster have pulled the main nave walls outward, causing severe separation along the edges of the masonry vaults. Bays closer to the main crossing tower have remained intact; however, at the west end of the Minster, the crack width between the walls and vaults has reached about 150 mm, leading to approximately 200 mm of sag at the crown of the vaults. Due to uneven settlement of buttresses along the nave of the church, the Minster now has ten nominally identical vaults at different damage states. In this work, two of these vaults representing the two extremes, the most damaged and undamaged structural states, are subjected to vibration testing with impact hammer excitation. From these vibration measurements, damage indicators are extracted in the modal, frequency, and time domains. In the modal domain, the

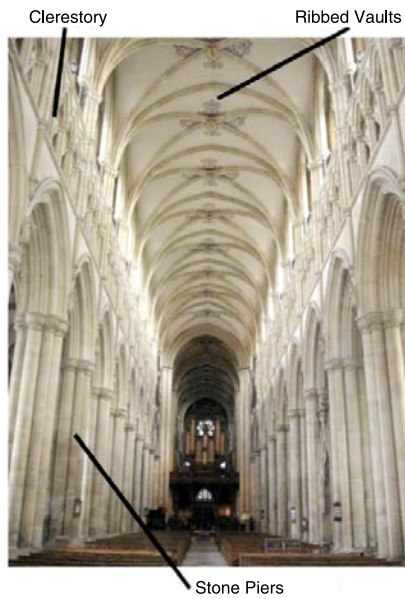
**Fig. 1.** The interior view of the nave of the Beverley Minster displays the limestone piers that support the stone vaulting. The leaning of the columns outwards is visually observable on site.

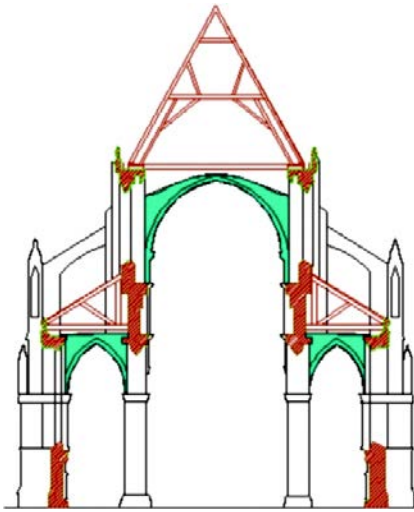
**Fig. 4.** The cross section of the vault displays how the stone walls and buttresses horizontally support the nave vaults. The settlement of the buttresses pulls the walls outward, causing separation between the walls and vaults.

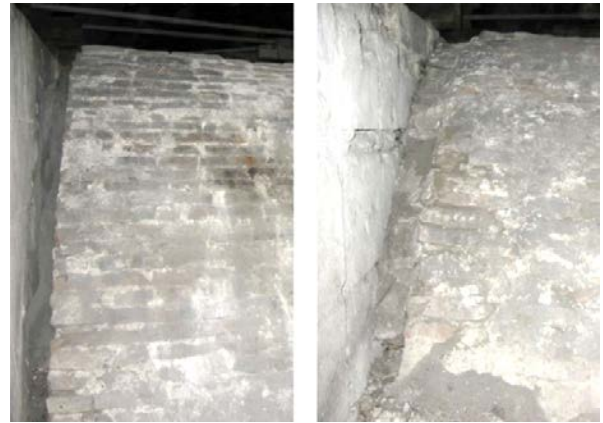
**Fig. 5.** The interface between the nave walls and vaults of (left) damaged and (right) undamaged vaults. The gap between the walls and vaults of the undamaged vault is filled with plastic sheets.

As seen in Fig. 5, while there is a gap between the walls and vaults for the damaged vaults, the brick webbing of the undamaged vault rests intact on the stonewalls. However, the degree of lateral restraint provided to the undamaged vaults by the nave walls is difficult to determine. During the finite element simulations, discussed in Section 5, this difference in the two vaults is represented as free lateral movement and restrained lateral movement.

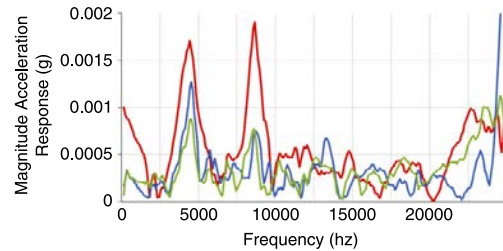
Fig. 7. The impact echo measurements are used to estimate the standard deviation of the homogenized material properties of the mortar and masonry assembly.

In this study, IE tests are conducted to estimate the natural variability of brick units and mortar assembly. A total of 30 tests are conducted at various locations on the vaults. During the tests, the vault webbing is impacted by a hardened steel ball and the localized, high-frequency vibrations caused by this impact are measured through a displacement transducer. The main resonant frequency of stress wave reflections between the internal and external boundaries of the masonry vault webbing is captured. Fig. 7 illustrates a select few of these measurements. From the dominant frequency, the overall time required for a single cycle is obtained. Assuming that the vault thickness remains constant, the material properties of the vaults are mathematically related to the velocity of stress waves. The variation in the ratio of Young's modulus over density of the masonry assembly is estimated to be roughly 10%.

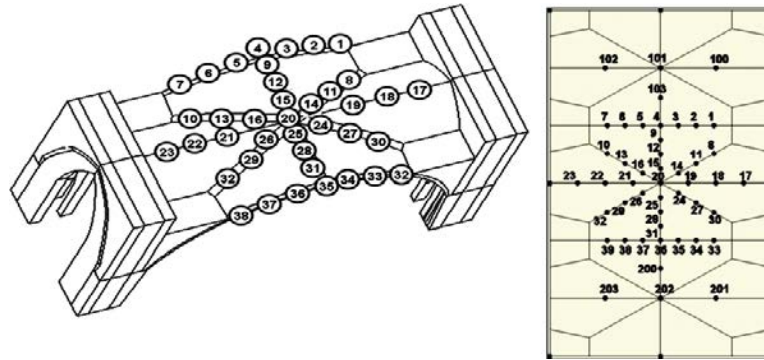
Fig. 11. A total of 39 measurement points are selected according to the mode shape predictions of the preliminary model. The excitation points are #20, #18, #12 and #11.

the measurement grid. The distribution of measurement points is determined according to preliminary finite element simulations of the vaults. The preliminary finite element model predicts modes as primarily composed of symmetric movements of the diagonal and orthogonal axes, as well as the crown. Based on this observation, a total of 39 measurement points are located at every quarter length on the main axis of the quadripartite vaults. To observe the interaction between the adjacent vaults, an additional eight measurement points are located on the two adjacent vaults (Fig. 11).

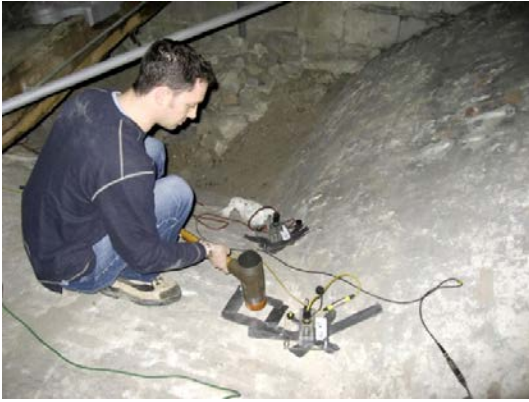
**Fig. 13.** The hammer operator exciting the pre-determined excitation points with the sledgehammer. Maintaining a relatively consistent excitation level is one of the keys for the success of hammer excitation.

A significant drawback of hammer excitation is the inability to replicate the impacts with consistent excitation force (Fig. 13). Although the hammer operator swung the hammer as consistently as possible, the excitation force during the experiments varied between 1800 and 2200 N throughout the tests. To reduce the degrading effects from this uncontrolled variation of impact force, as well as from ambient noise, five impacts are performed and the responses are averaged for each excitation location.

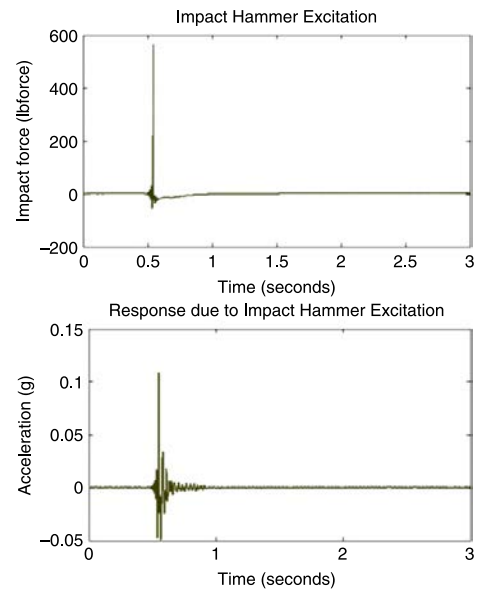
**Fig. 14.** Examples of measured signals: (top) hammer impact force in the time domain and (bottom) the response of the vaults due to the hammer impact.

A typical time history measurement of the hammer impulse and of the associated vault response is shown in Fig. 14. These time domain measurements are readily converted into the frequency domain by the spectrum analyzer. In the frequency domain, measured vault response is normalized with respect to the corresponding hammer impulse. This normalization process yields the experimental counterpart of the previously introduced frequency response function (FRF). Moreover, the coherence functions are obtained from the five repeated measurements. Coherence functions

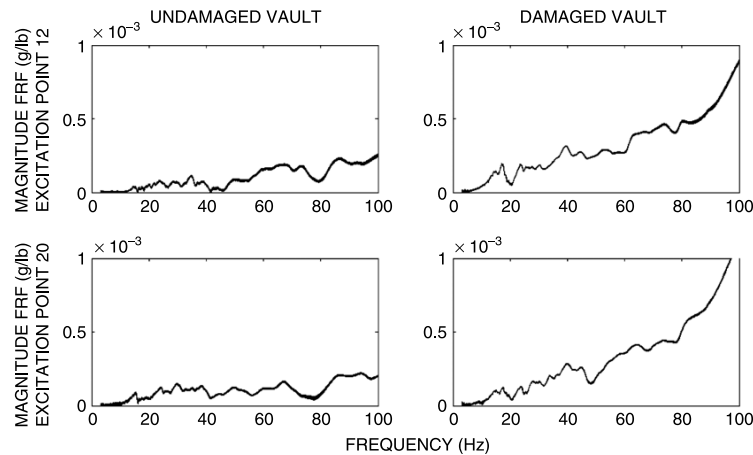
Fig. 16. The frequency response function of the damaged vault tends to have higher amplitudes compared to the undamaged vault, especially at higher frequencies.

From the coherence functions, the uncertainty in magnitude and phase FRFs can be computed using Bendat and Piersol's [31] formulation. This approach assumes that FRF variability is random and follows a Gaussian distribution. The variability of FRFs with one standard deviation is shown in Fig. 16. Fig. 16 was developed using driving point measurements—the excitation and measurement of the same point. The standard deviation is derived using two driving point FRFs collected from points 12 and 20. Fig. 16 illustrates that while the standard deviation of the FRFs obtained from undamaged and damaged vaults are comparable, the FRF amplitudes are generally higher for the damaged vault than they are for the undamaged vault. It is plausible that the damage introduced high amplitude, local modes at a frequency higher than 100 Hz. From Fig. 16, it is evident that such a high amplitude local mode is not present for the undamaged case.

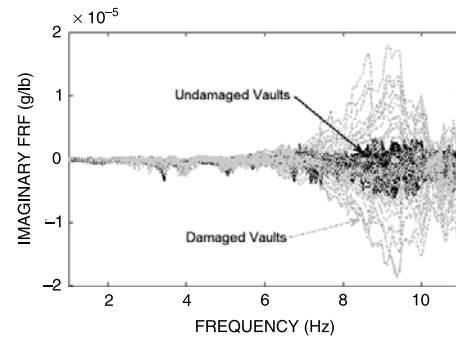
**Fig. 19.** The imaginary component of the FRF conveys the relative deformations of the measurement points, which are observed to be comparable for the damaged (red dashed) and undamaged (blue solid) vault for frequencies below 7 Hz. Frequencies higher than 7 Hz have significantly higher amplitudes for the damaged vaults.

Overlaying FRFs obtained from the damaged and undamaged vaults gives a visual indication of change between the structures. As Fig. 19 shows, the FRFs obtained from the two vaults agree relatively well up to 7 Hz. For higher frequencies, the FRF obtained from the undamaged vault has significantly lower amplitudes than the FRF obtained from damaged vault. The same trend is observed consistently in all FRFs (Fig. 19) and is in agreement with the simulated response of the vaults as given in Fig. 10. Through this visual assessment, the FRFs yield a clear indication that a change between the two structural systems has occurred. This observation is consistent with the FRFs simulated by the FE model (see Section 4), as indicated in Fig. 10. If the onset of damage introduces nonlinearity to a predominantly linear system, then coherence functions can be used as damage indicators. A typical coherence function, corresponding to the driving point measurement at the crown of the undamaged vault, can be seen in Fig. 20. The coherence functions of the damaged vaults are observed to be lower than those of the undamaged vaults, possibly due to system damage amplifying the nonlinearity of the vibration response.

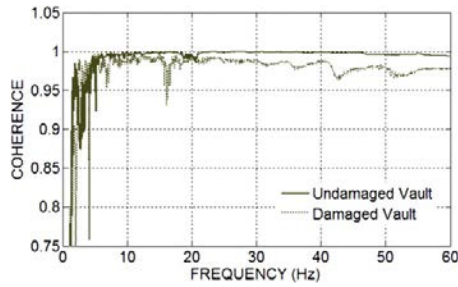
Fig. 20. The coherence plot indicates the linear relationship between the input force and output response. The damaged vault coherence plot shows a reduction in this linear relationship.

Using the coherence functions in addition to FRFs may provide a diagnostic that, while being insensitive to environmental and testing variability, correlates well with the presence of structural damage.

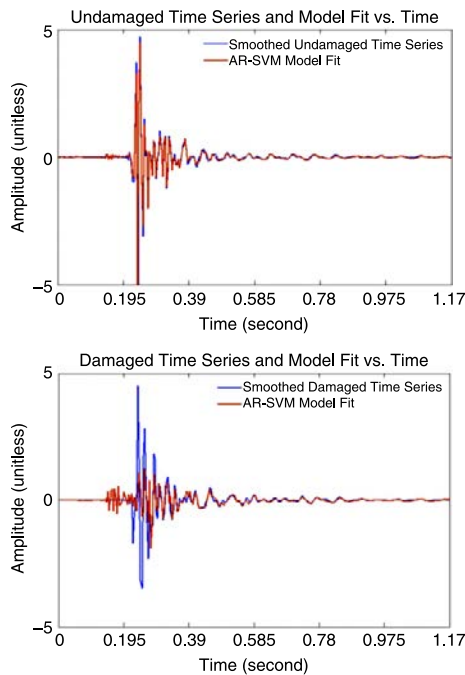
**Fig. 21.** Comparison of AR-SVM fit to normalized transient impact data in (top) undamaged and (bottom) damaged cases. Average absolute residuals for this sensor in the undamaged and damaged cases are 0.0412 and 0.1308 respectively, indicating significantly improved model fit to the undamaged case.

This procedure is repeated for all 46 sensor locations, excluding the crown for which a complementary sensor location does not exist. Examples of time series and AR-SVM model fits for both the undamaged and damaged vault are shown in Fig. 21. It can be observed that the model fit to the undamaged vault data, although not perfect, is far superior to the model fit to the data from the damaged vault. Examining the lack-of-fit residuals of AR-SVM predictions for all sensor locations reveals that the undamaged case has a significantly stronger goodness-of-fit. This can be quantified using, for example, statistics from the lack-of-fit residuals. The average absolute value of residual error is plotted for each sensor location in Fig. 22, sorted according to values of the damaged vault. A  $t$ -test statistic, which tests for equal means between two normally distributed samples, indicates a systematic difference between the two datasets with a  $p$ -value below  $10^{-15}$ . Generally  $p$ -values below 0.01 are considered to correlate with strong evidence. Therefore, we conclude from both graphical observation and statistical testing that the AR-SVM models provide a significantly better fit to the undamaged vault. Because the training of AR-SVM models included a cross-validation step to prevent over-fitting and to improve prediction under various sources of variability, we conclude that the systematic lack-of-fit observed when applied to signals collected on the damaged vault come from structural damage.

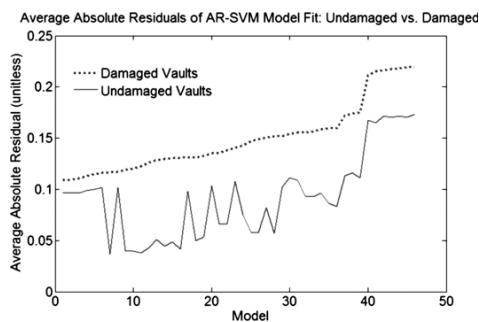
**Fig. 22.** Average absolute values of lack-of-fit residuals of AR-SVM predictions at 46 sensor locations for the undamaged and damaged cases.
